Nongroundwater Remedial Investigation Report

Reynolds Metals Company
TROUTDALE FACILITY

CH2MHILL

August 1999

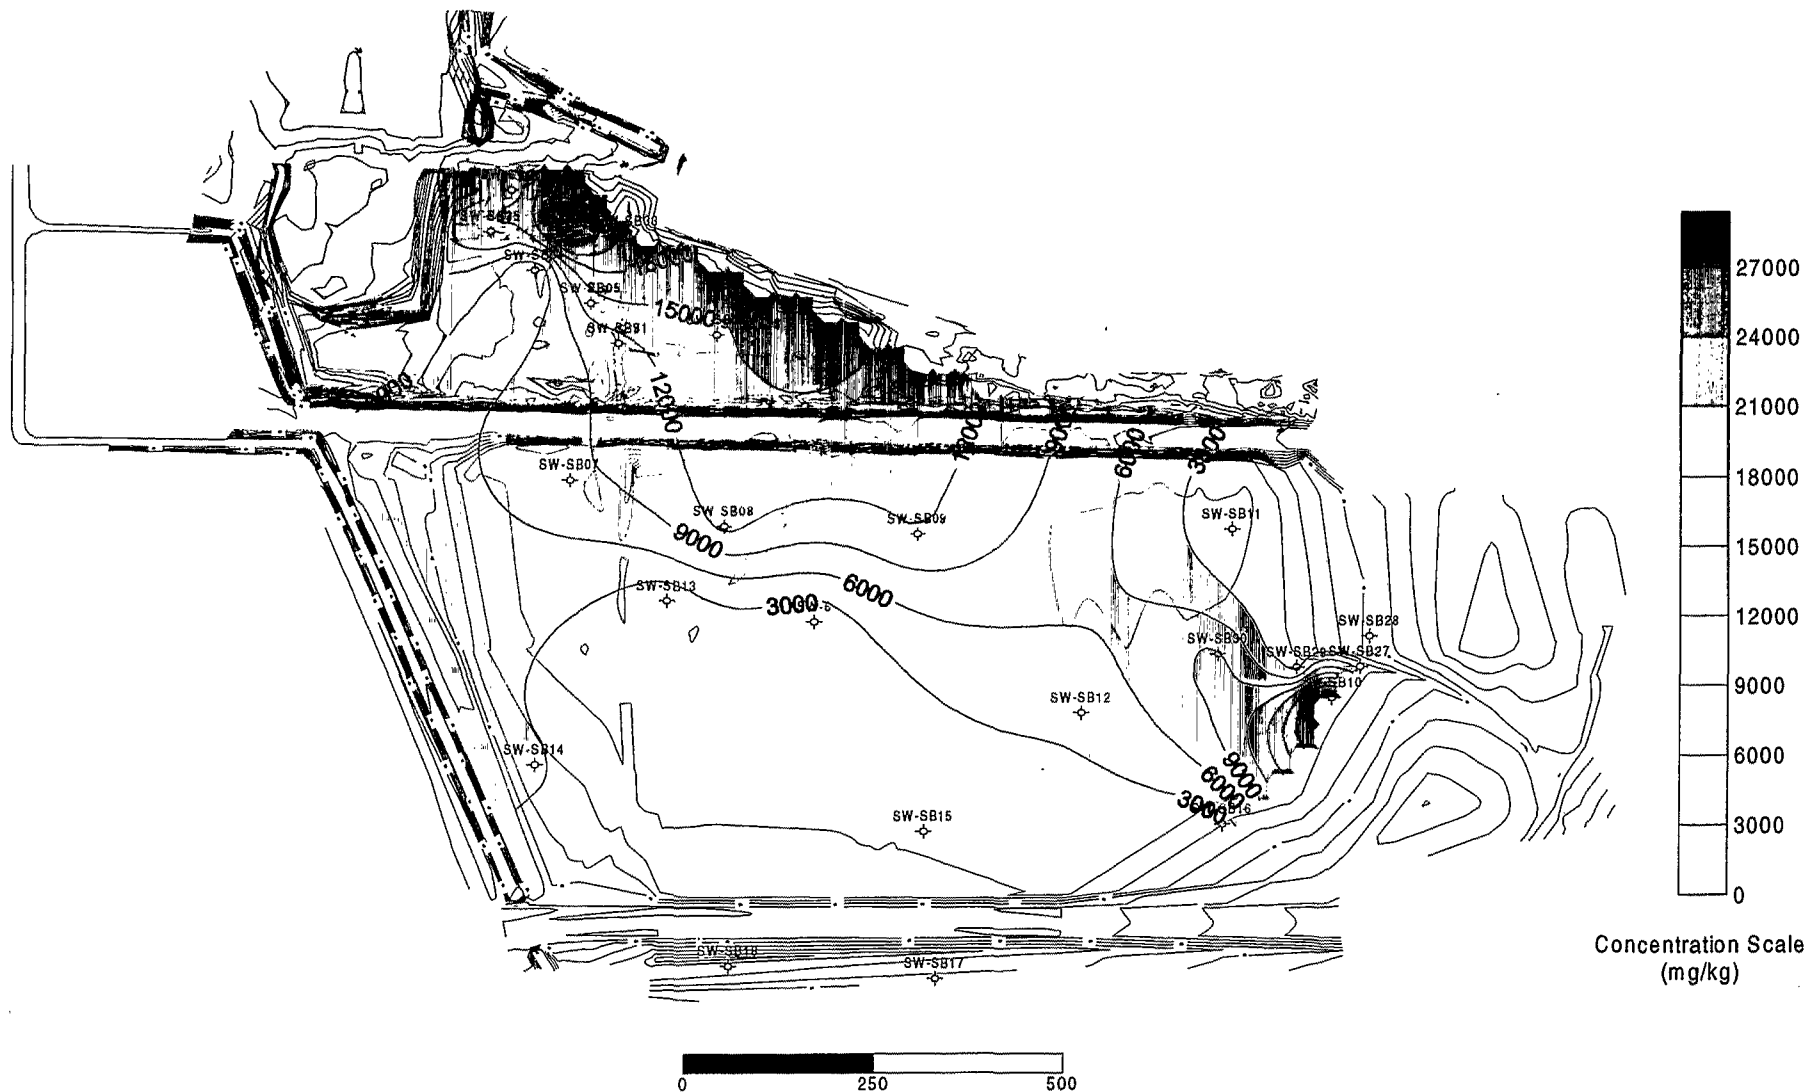
Figure 3-3
 FLUORIDE DISTRIBUTION IN SOUTH WETLANDS SURFACE SOIL
 REYNOLDS METALS COMPANY
 TROUTDALE, OREGON
 Nongroundwater Remedial Investigation Report

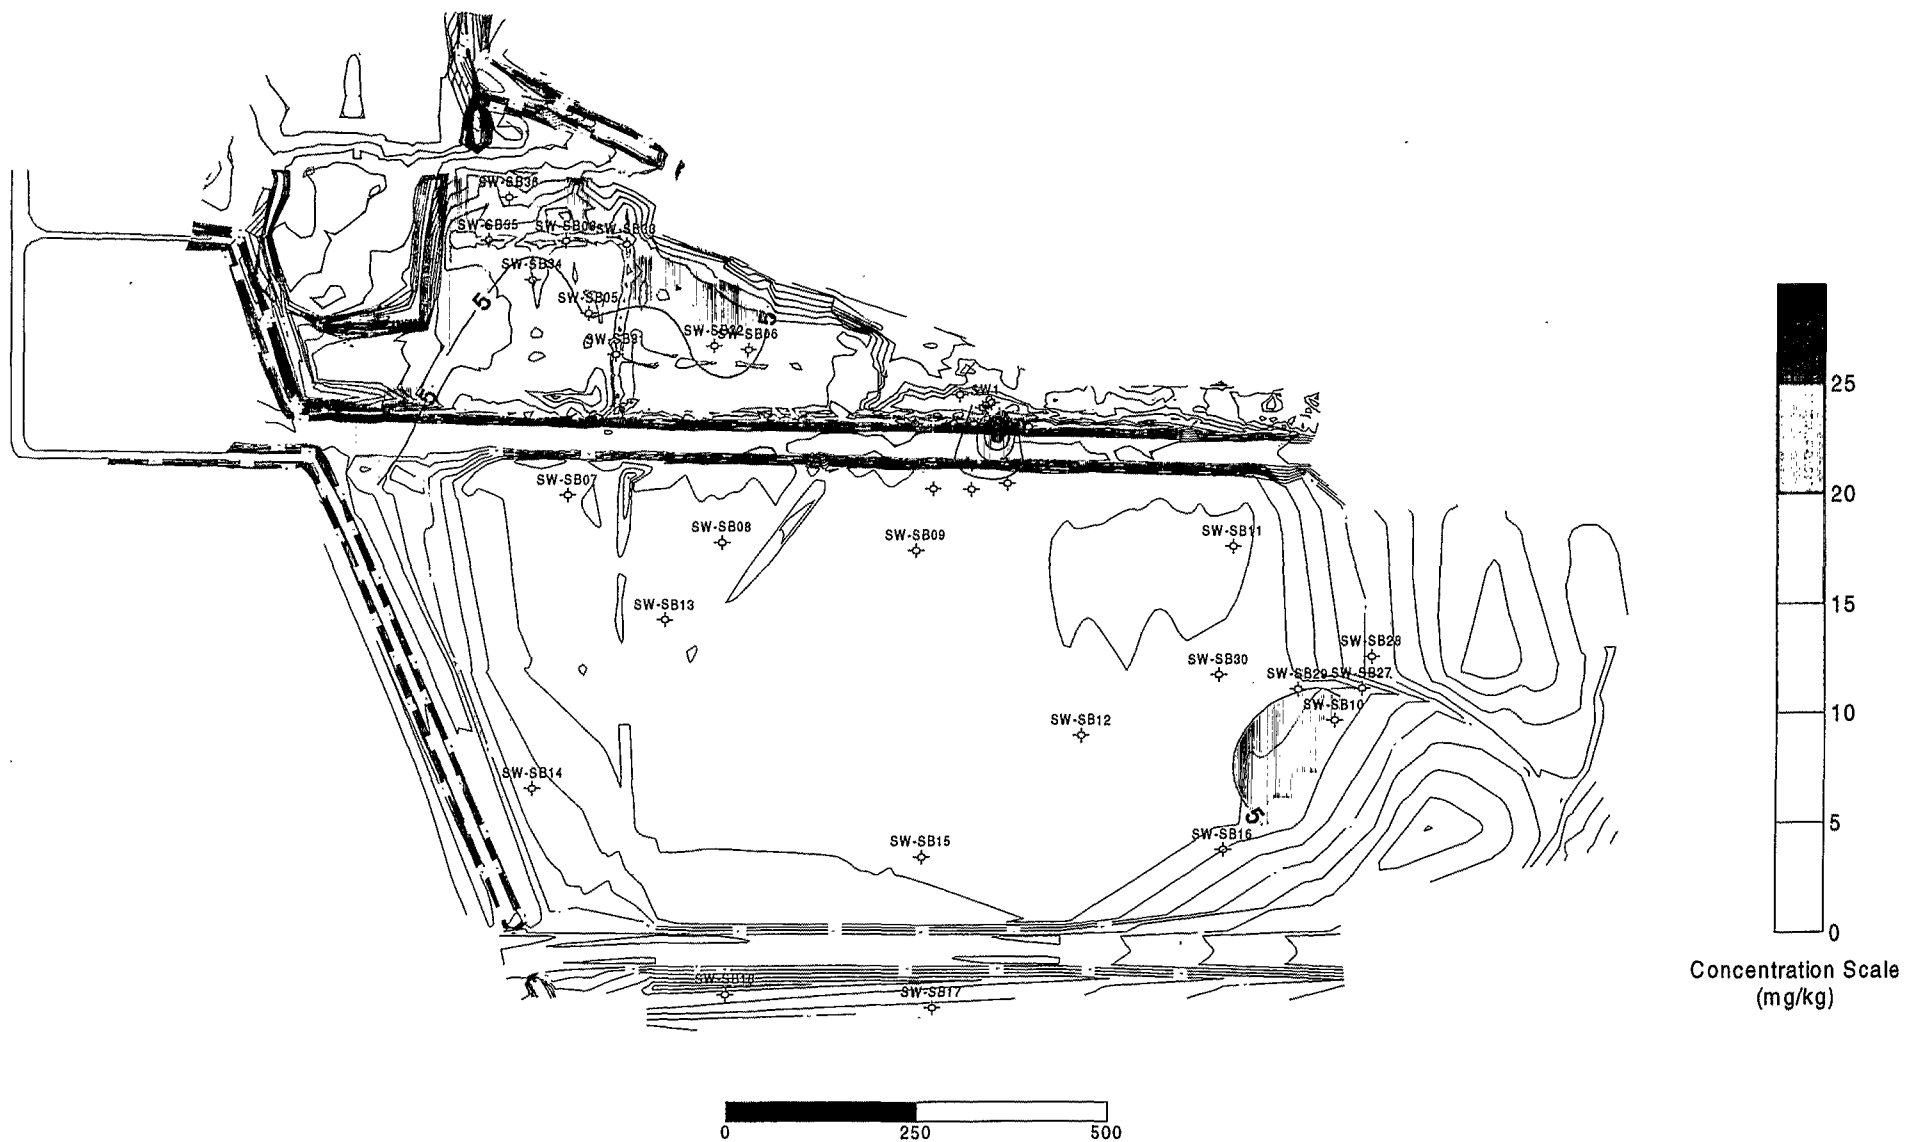
Figure 3-4
 TOTAL PCB DISTRIBUTION IN SOUTH WETLANDS SURFACE SOIL
 REYNOLDS METALS COMPANY
 TROUTDALE, OREGON
 Nongroundwater Remedial Investigation Report

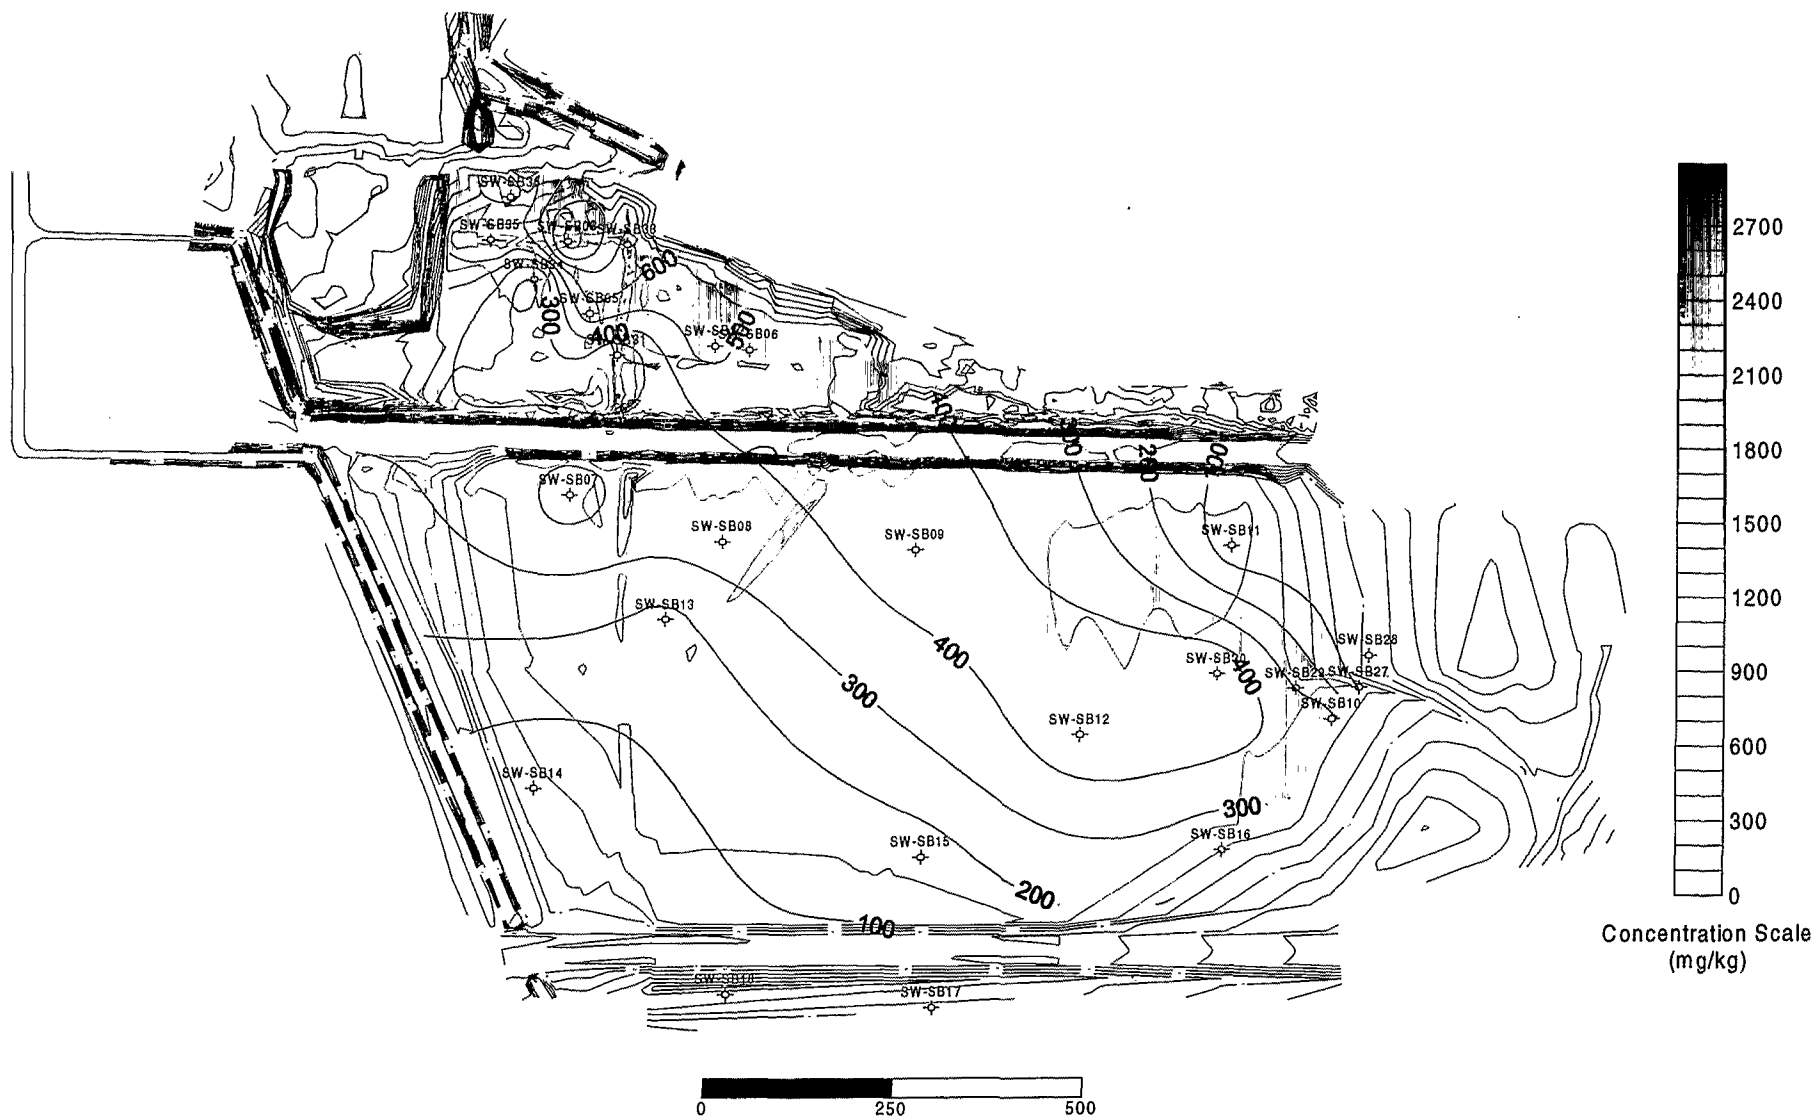
Figure 3-5
 COPPER DISTRIBUTION IN SOUTH WETLANDS SURFACE SOIL
 REYNOLDS METALS COMPANY
 TROUTDALE, OREGON
 Nongroundwater Remedial Investigation Report

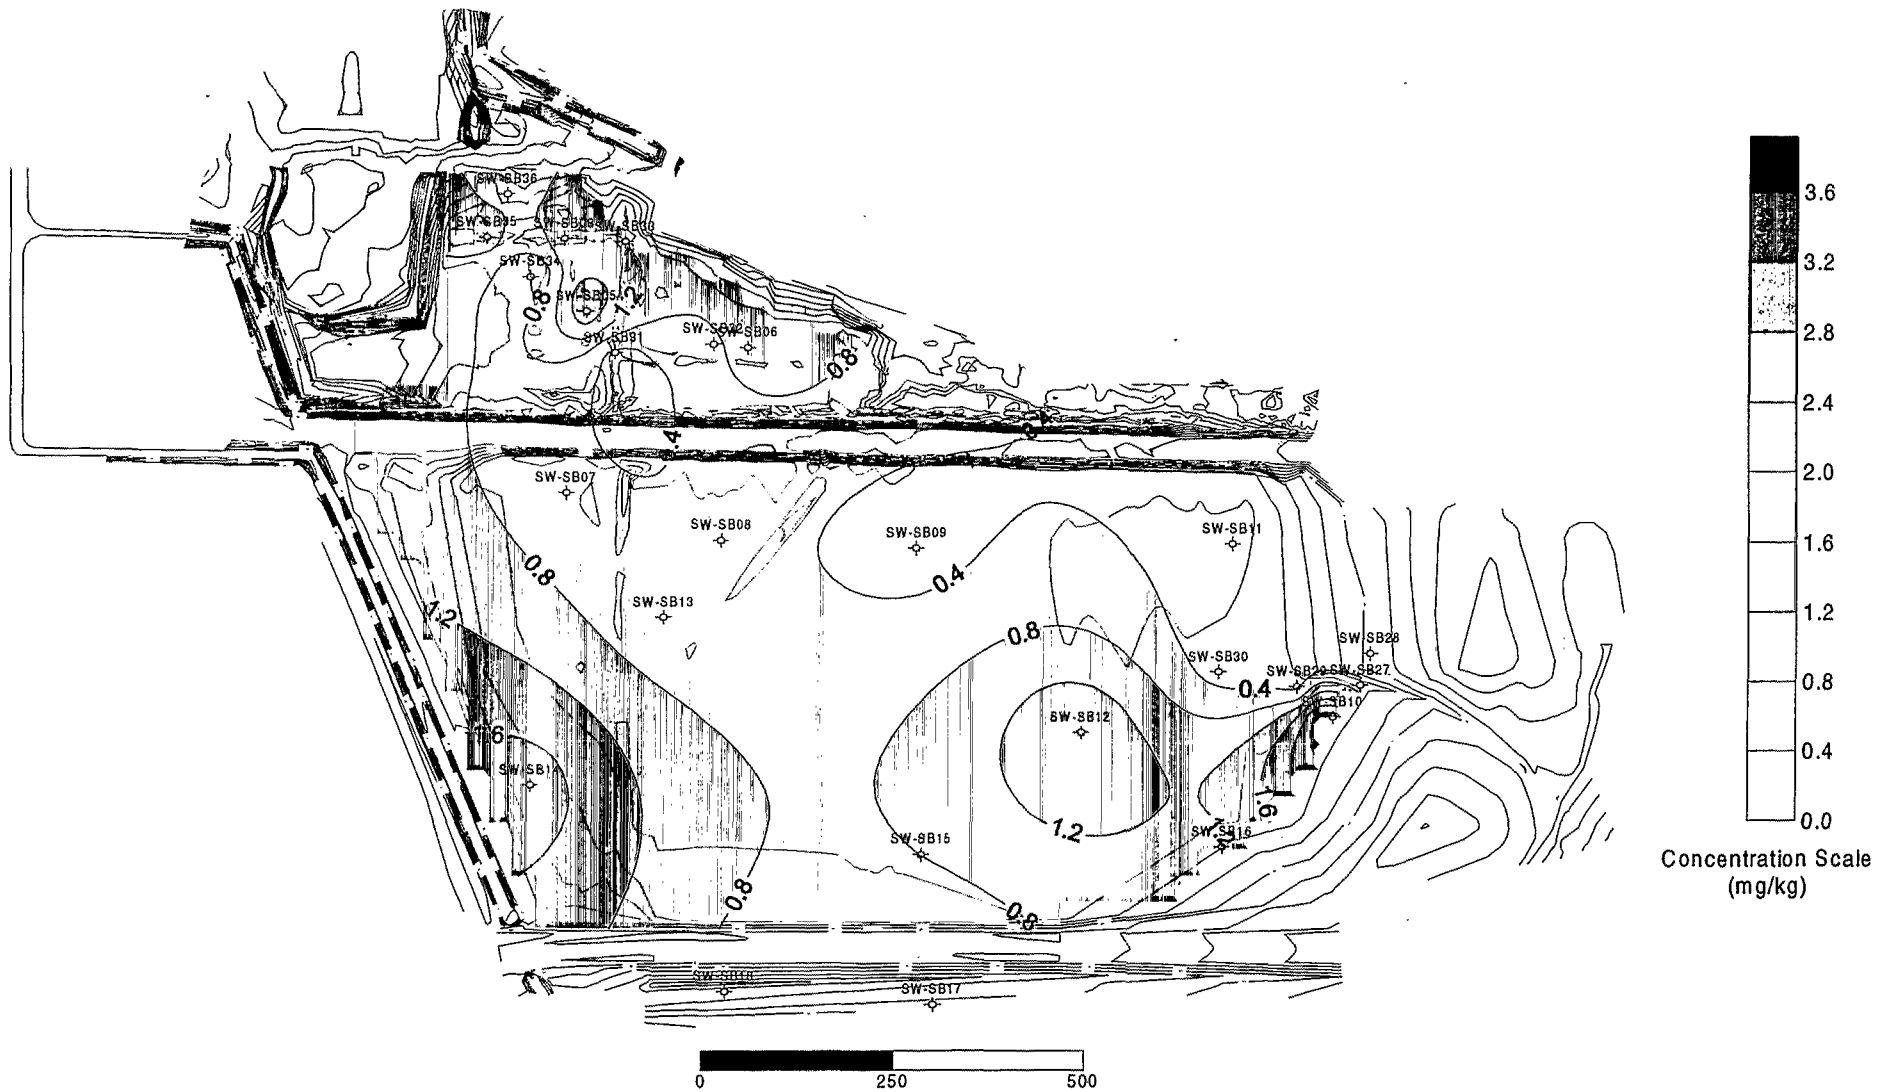
Figure 3-6
 MERCURY DISTRIBUTION IN SOUTH WETLANDS SURFACE SOIL
 REYNOLDS METALS COMPANY
 TROUTDALE, OREGON
 Nongroundwater Remedial Investigation Report

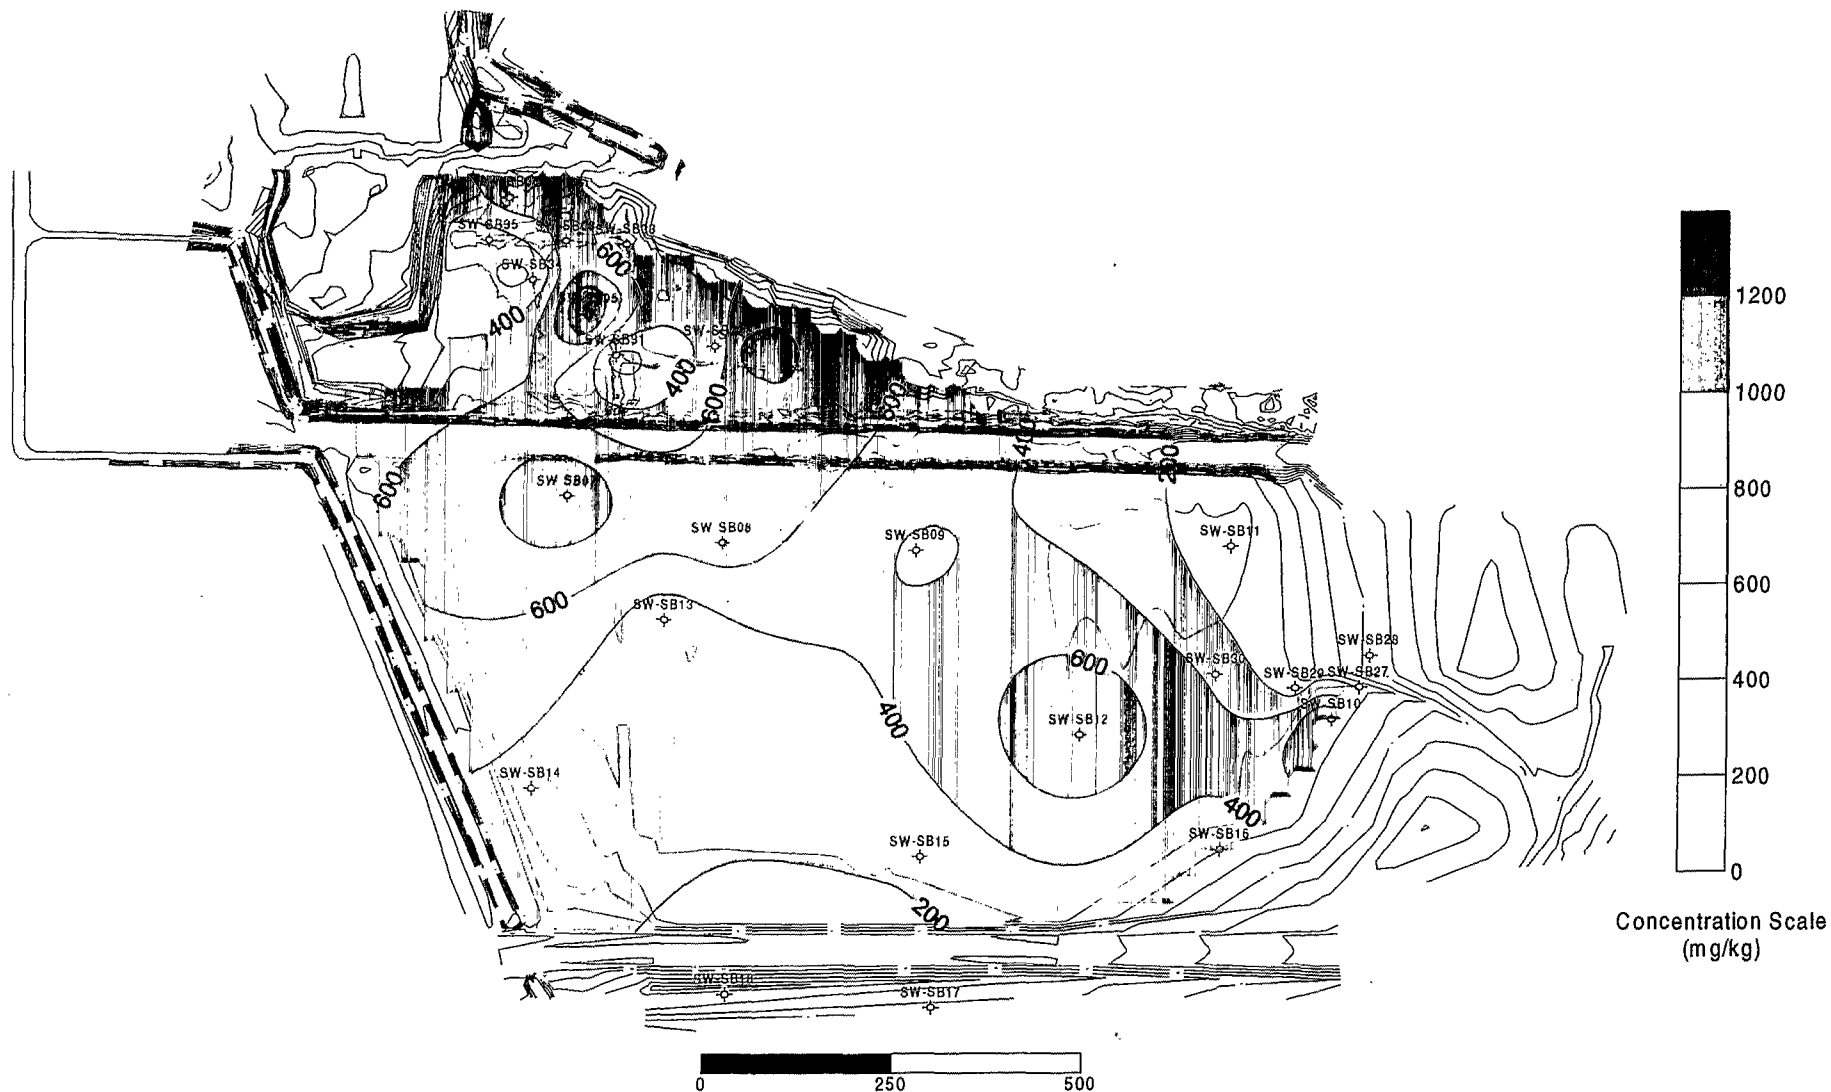
Figure 3-7
 VANADIUM DISTRIBUTION IN SOUTH WETLANDS SURFACE SOIL
 REYNOLDS METALS COMPANY
 TROUTDALE, OREGON
 Nongroundwater Remedial Investigation Report

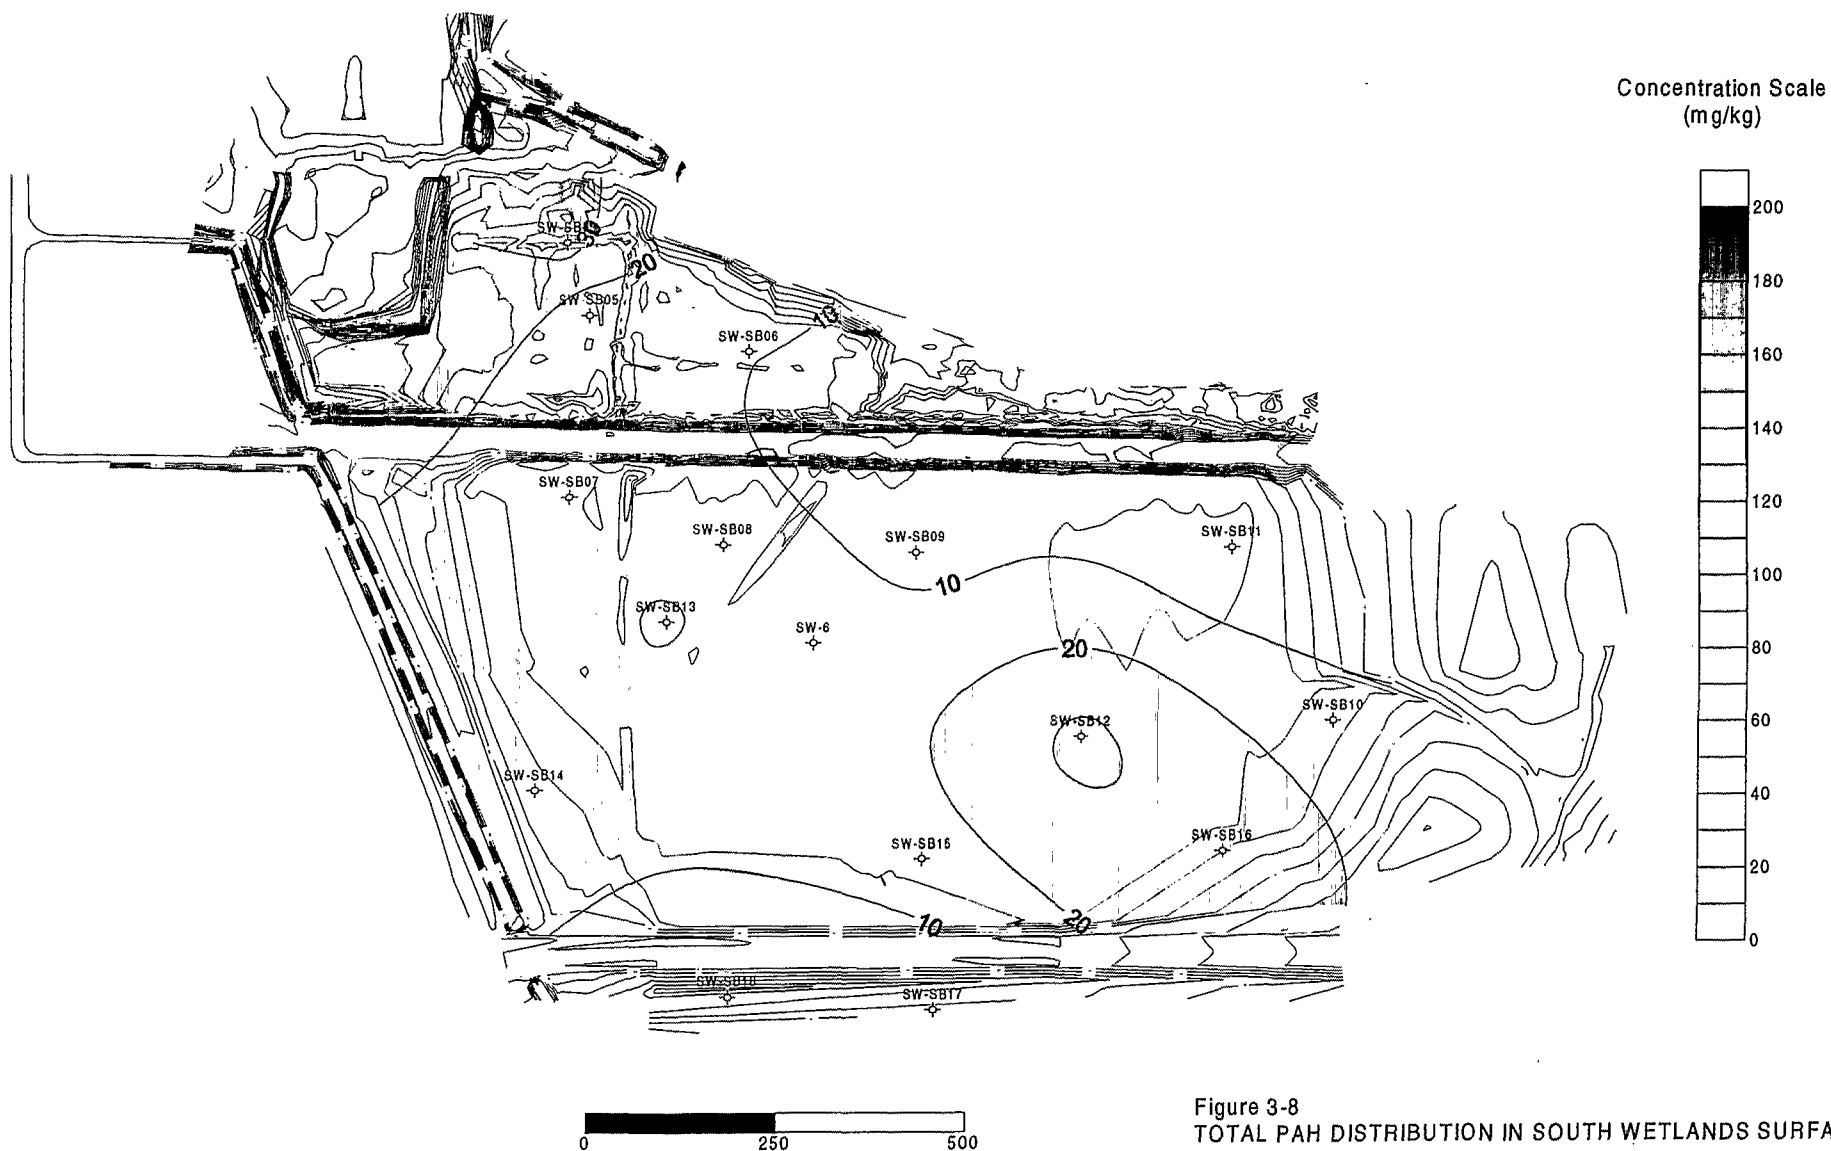
Figure 3-8
TOTAL PAH DISTRIBUTION IN SOUTH WETLANDS SURFACE SOIL
REYNOLDS METALS COMPANY
TROUTDALE, OREGON
Nongroundwater Remedial Investigation Report
